ASCEND SPRING 2026 Glendale Community College

State Penitentiary

General Overview

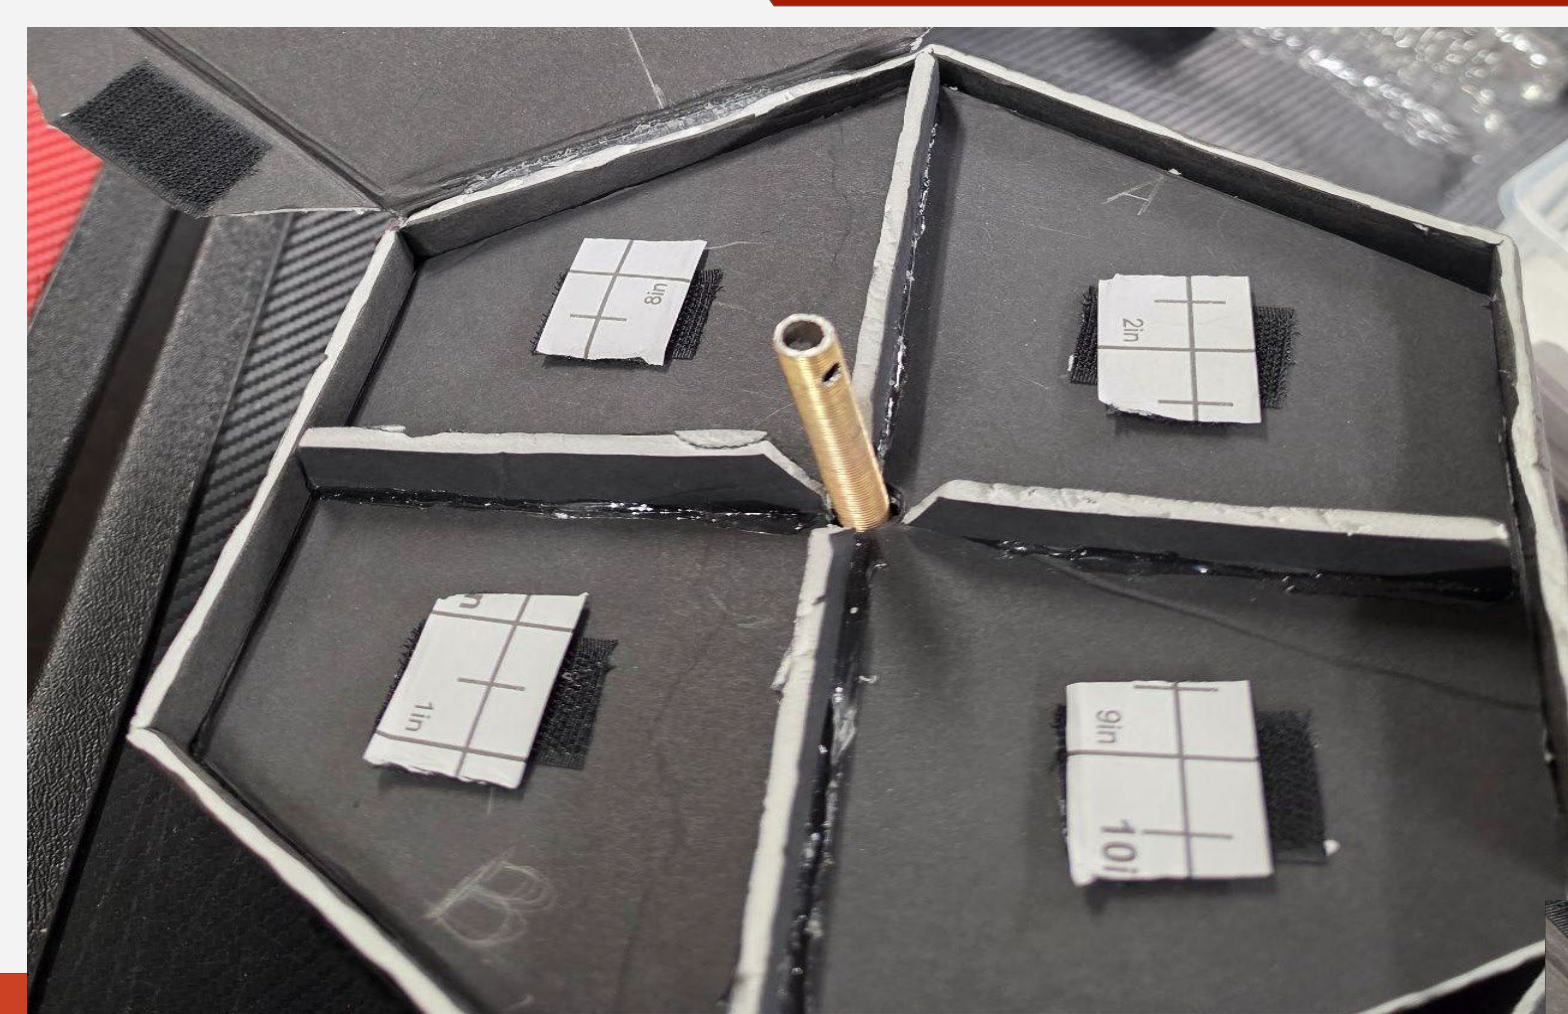
Upper level compartment reserved for biology experiment

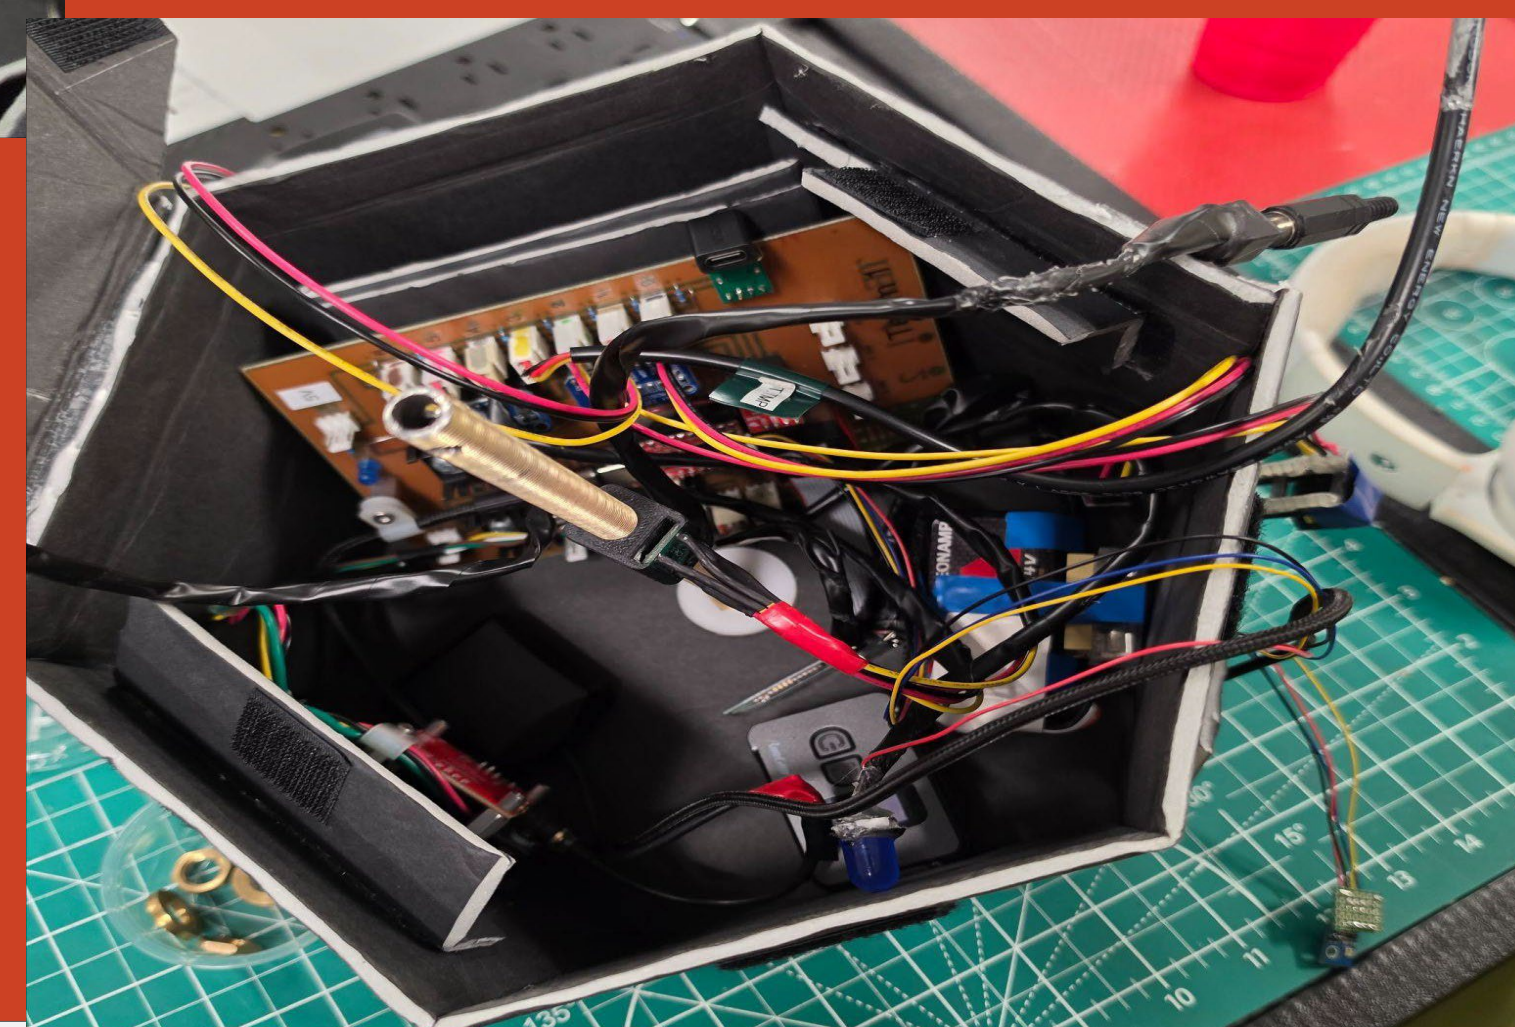
Lower level compartment for housing FDR, sensors, camera, and battery

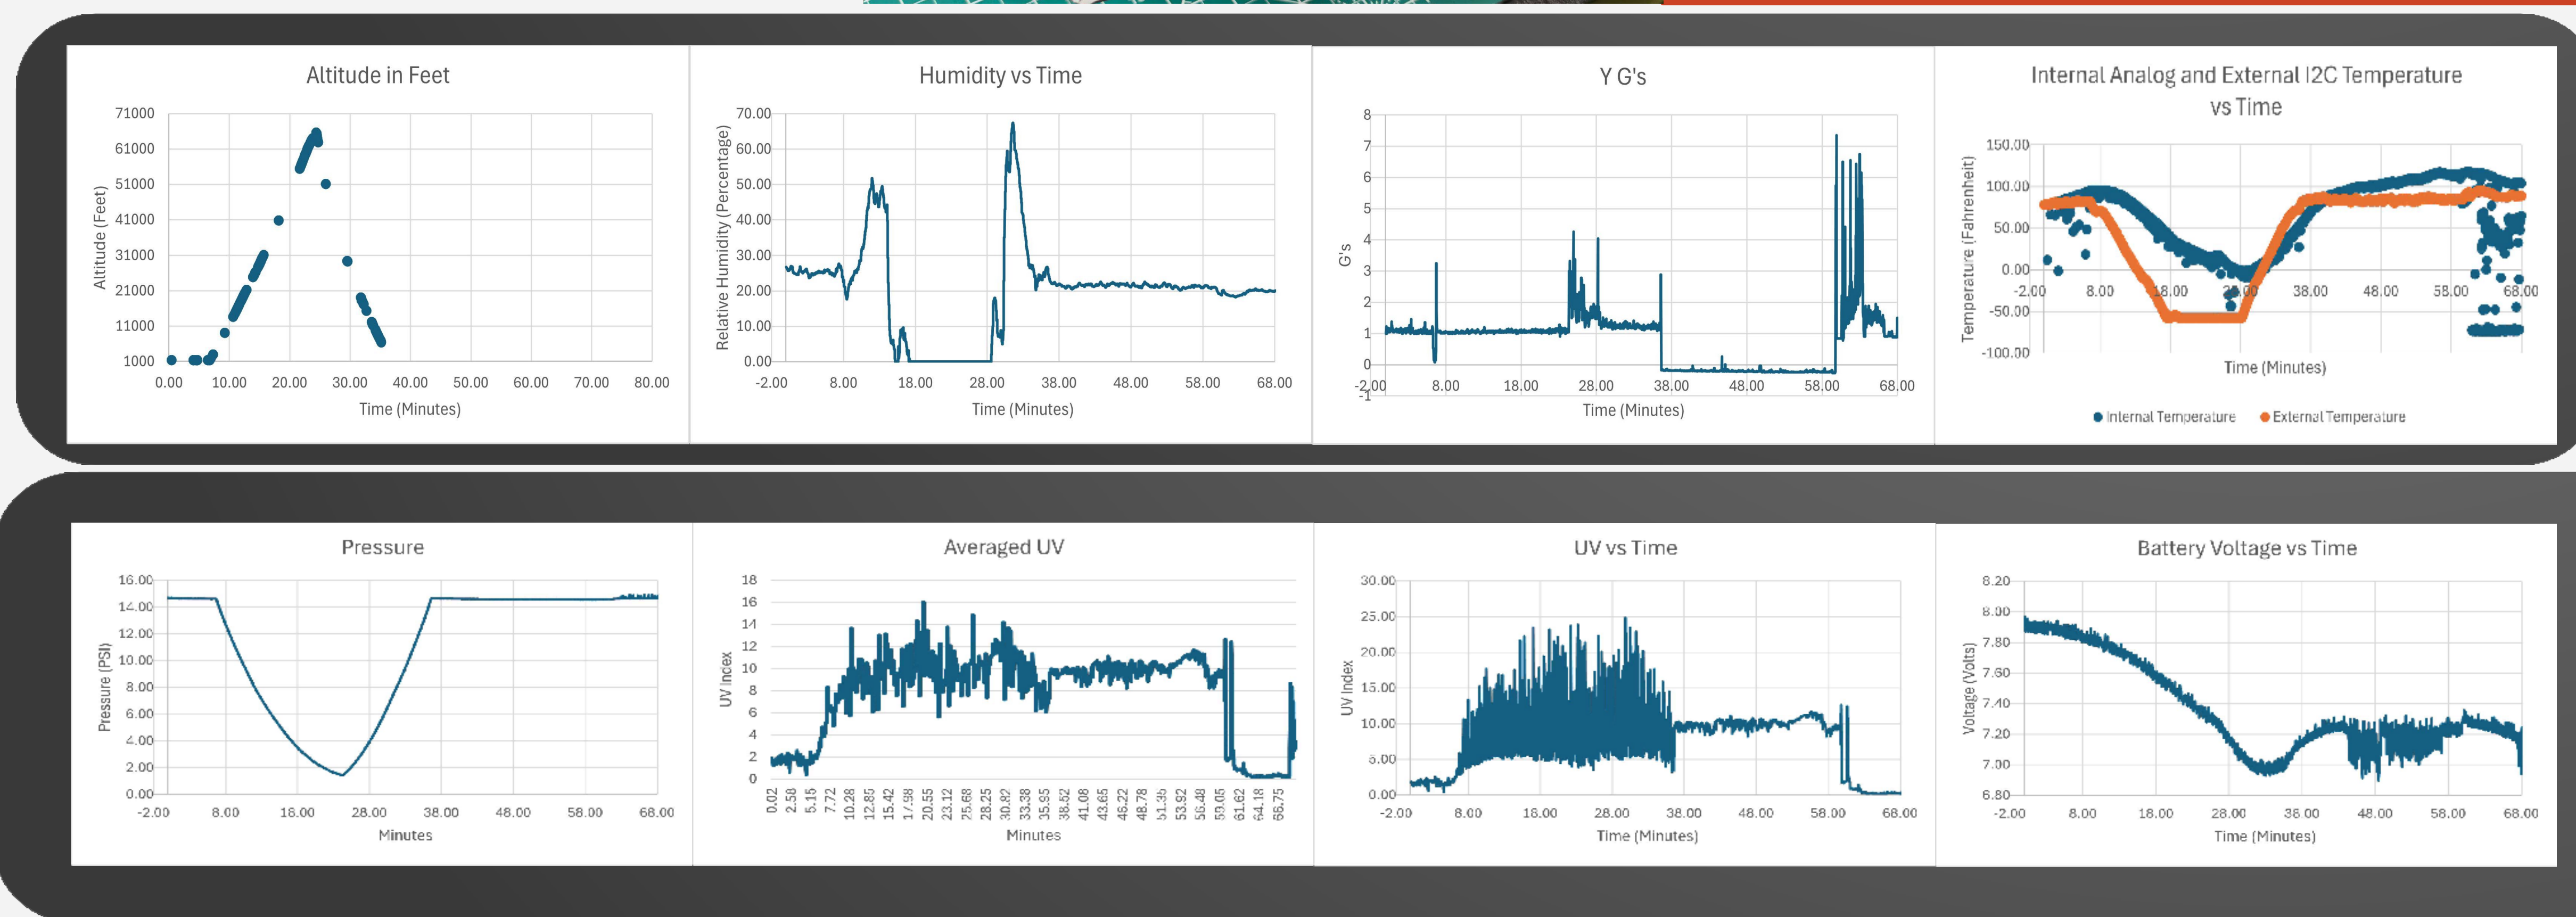
Bio Experiment

- New mission element focused on a **biological exposure study** using *Deinococcus radiodurans* (a type of bacteria).
- The payload enclosure was modified with **top and side access points** to support the biology hardware.
- **Seven desiccated samples** were placed at different locations in the payload to expose them to different **UV radiation conditions** during flight.
- After recovery, the samples are **rehydrated** and evaluated through **colony count growth analysis**.
- Biological results will be compared against recorded **UV, temperature, and altitude** data from the payload.
- Goal to show the **resistance** of this bacteria **under stressor conditions** unlike ground level.
- Final biological results are **still pending**.
